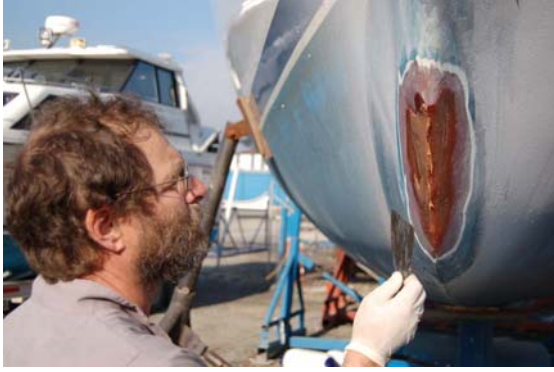
David Ratner doing the first epoxy layer on the bow

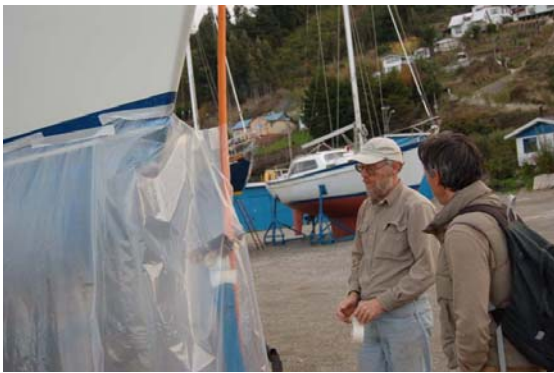
To keep the heat in a plastic tent was set up for the epoxy to cure. David Masters and Claude Gosselin also helped patch up Red Thread's underside.

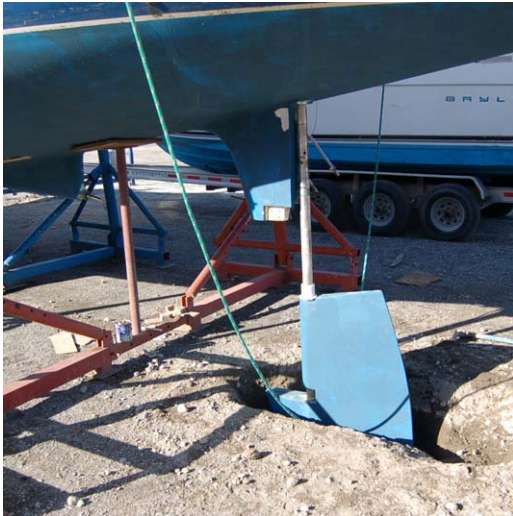
The rudder had to be removed for repair. The bottom 6 inches were torn off by the rocks, but the boat sailed all the way to port despite the damage.

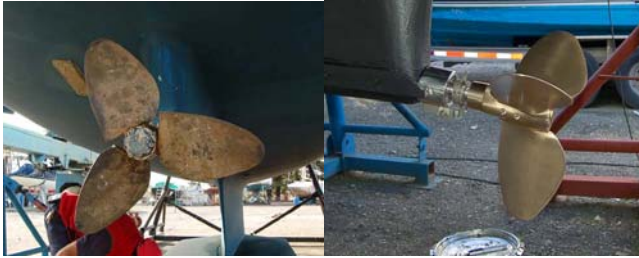
Before and after propeller notice on the left the upper blade turned wrong way. Cutters were added to the new propeller.

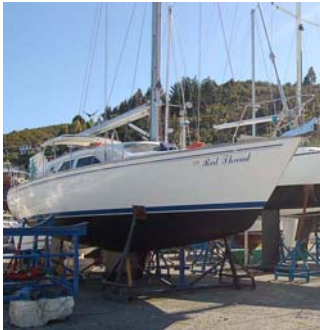
New Bottom and all hull repairs completed.

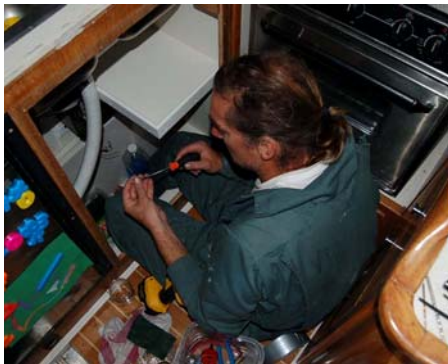
Work, work work, repairing the refrigerator. How did this break by going on the rocks?

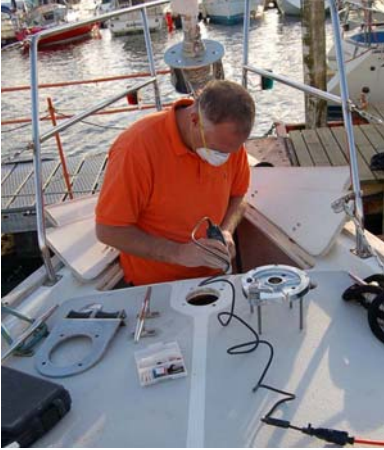
Brothers are good for many things like breathing fiberglass. The windlass was replaced thanks to Maxwell America for the new parts and thanks to Bryan for the labor.

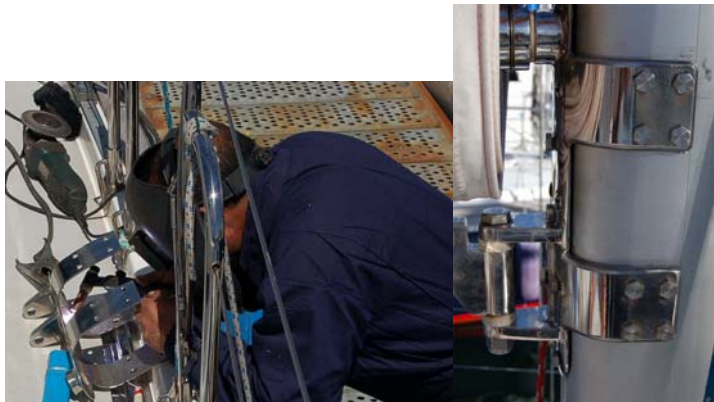
The gooseneck for the mast needed to be rebuilt. Now there are 4 8mm plates that wrap around the mast.
